# Elk Rapids River Corridor Assessment 2022

*By Noah Jansen, Restoration Coordinator*

*Tip of the Mitt Watershed Council*

## Priority Survey Areas for the 2022 Elk River Corridor Assessment for the Village of Elk Rapids

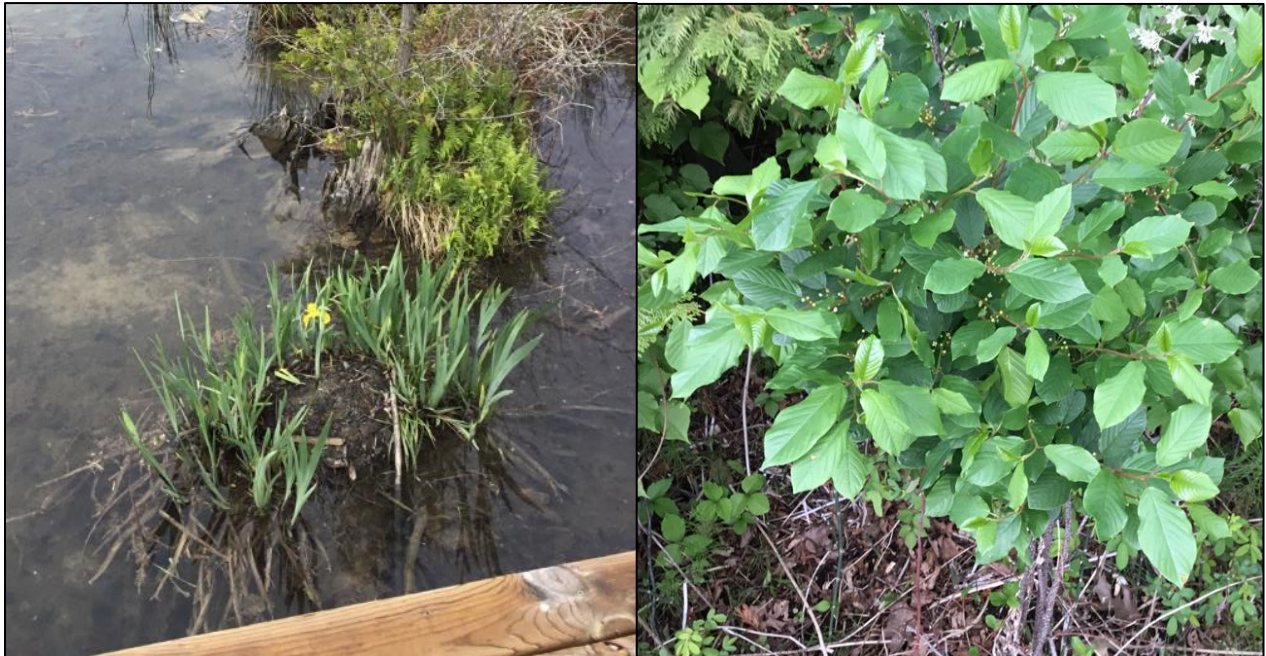
*Figure 3: Invasive species yellow flag iris (left) and glossy buckthorn (right) found in the Elk River corridor*

- b. Only one yellow flag iris was found. It can be removed by pulling or digging. Since the sap is poisonous and may cause a skin reaction, gloves and protective clothing should be worn when working with yellow flag iris. Care should be taken to remove all rhizomes, as re-growth will occur from missed rhizomes. An aquatic approved herbicide could also be used to control yellow flag iris, but an aquatic nuisance species permit from the Department of the Environment, Great Lakes, and Energy (EGLE) is required for application of pesticides to/over water.

- c. Only a few stems of glossy buckthorn were found, along the boardwalk on the north side of the river. These can be manually removed using a weed wrench (available for check out at Boyne City Library) or work with CAKE CISMA to apply chemical treatments (e.g. cut-stump application).

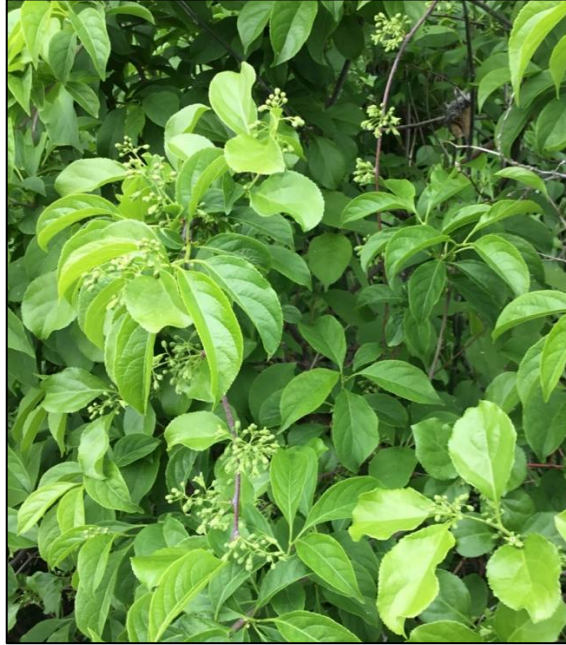
*Figure 4: Invasive species Oriental bittersweet*

2. Work with the CAKE CISMA or a private contractor to control Oriental bittersweet. This species is a high priority for control in our region as it is not believed to be widespread yet. However, it is somewhat common in parts of the river corridor and will thus take more resources to control. It is most effective to use herbicides in the control of Oriental bittersweet, so partnering with CAKE or finding a contractor experienced in bittersweet control is recommended.

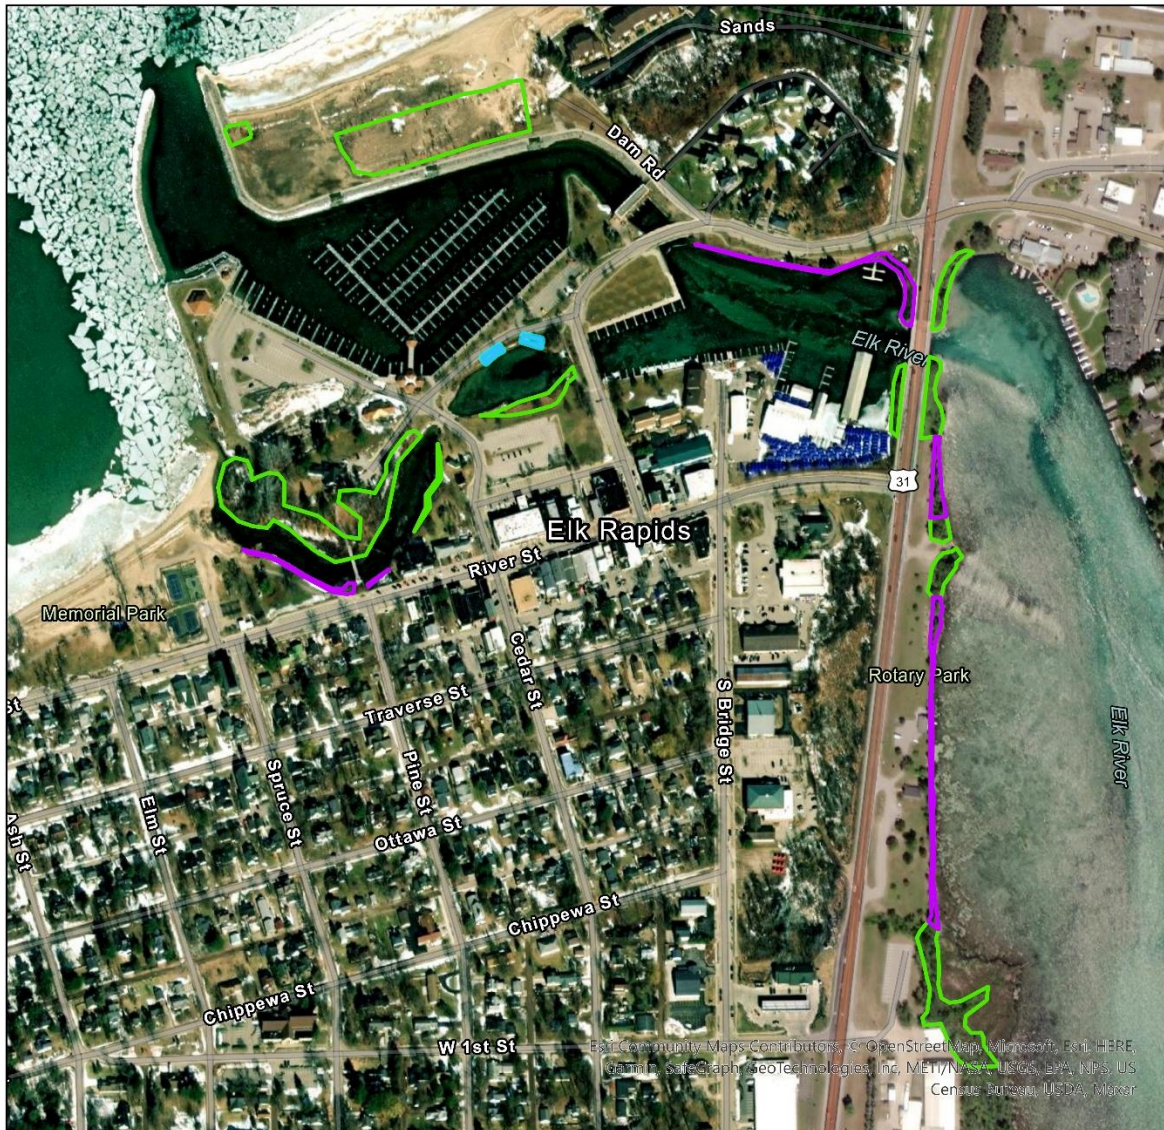
The Watershed Council generally promotes a greenbelt width of at least 50 feet, as measured perpendicular to the water's edge. There are only a few places along the river corridor where this recommendation is met, including the north side of the south branch (behind the library) and between the beach and the river on the north side of the north branch. However, a narrower greenbelt still provides some water quality benefits. Narrower greenbelts are found in several locations, as shown in Figure 4.

Figure 6: Greenbelts bordering the Elk River. Existing greenbelts are outlined in green. Existing greenbelts which are priorities for expansion or enhancement are shown in purple, while priority areas for greenbelt creation are shown in blue.

1. Expand and/or enhance greenbelts in priority areas by planting native plants or establishing no-mow zones, allowing native plants to recolonize areas that are currently mowed. If greenbelt cannot be widened to the full 50 feet, expanding the greenbelts as much as practicable will still provide some benefits. Priority areas are shown in the map (below) in purple, and include:

- a. On the south side of south branch of the river, both east and west of the south end of footbridge, enhance and widen greenbelts with added native plants.

- b. On steep banks south of Harbor Drive, between Dexter and Cedar Streets, especially, which would benefit from deep-rooted native plants to increase stability.

- c. Rotary Park
  - d. Along the north side of the river between US-31 and the dam
  - e. Expand the west end of the greenbelt on the south side of the south branch between Dexter and Cedar Streets

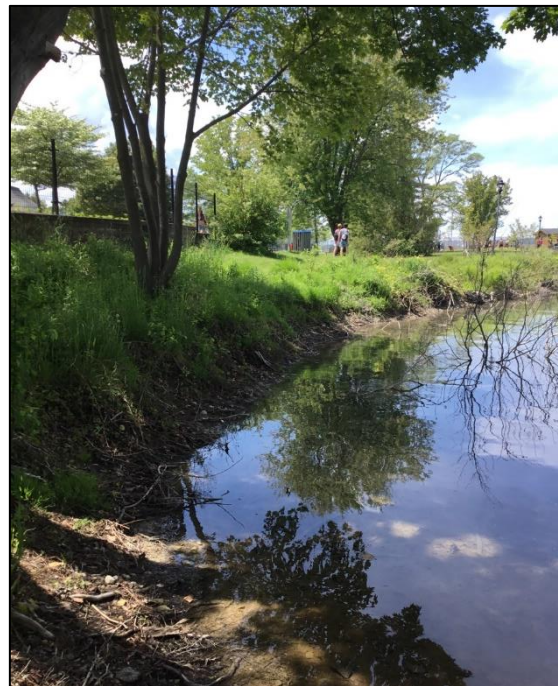
- Point 1 (Figure 8): On the south side of the south branch, west of the south end of footbridge – erosion at the base of the streambank
  - Enhance with riparian native shrubs, such as *Cephalothins occidentalis* (buttonbush), *Cornus amomum* (silky dogwood), *Cornus sericea* (red-osier dogwood), *Salix amygdaloides* (peach-leaf willow), *Salix bebbiana* (Bebb's willow), *Salix discolor* (pussy willow), *Salix exigua* (sandbar willow), *Salix eriocephala* (heart-leaved willow), *S. sericea* (silky willow), *Viburnum trilobum* (American highbush cranberry), and *Viburnum prunifolium* (black-haw).

*Point 1: Eroding bank along south side of the south branch of the Elk River, near the footbridge*

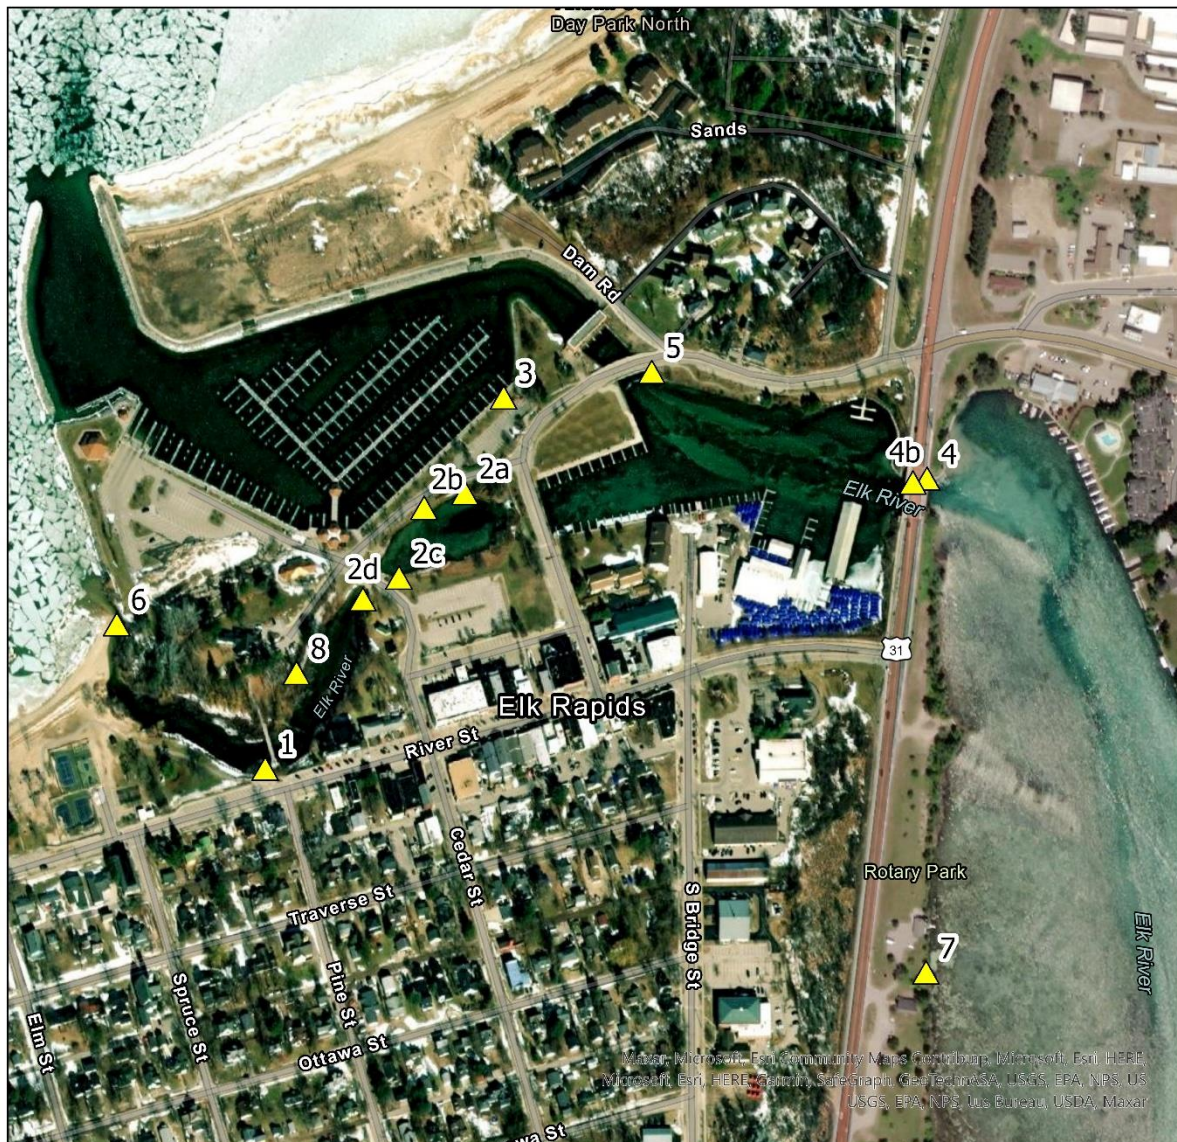
Erosion and places with bare soil (susceptible to erosion) were found at several points along the Elk River corridor, as shown in Figure 7.

Figure 7: Priority areas for restoration and enhancement plantings along the Elk River corridor. The description of each numbered point and its recommendations can be found in the text.

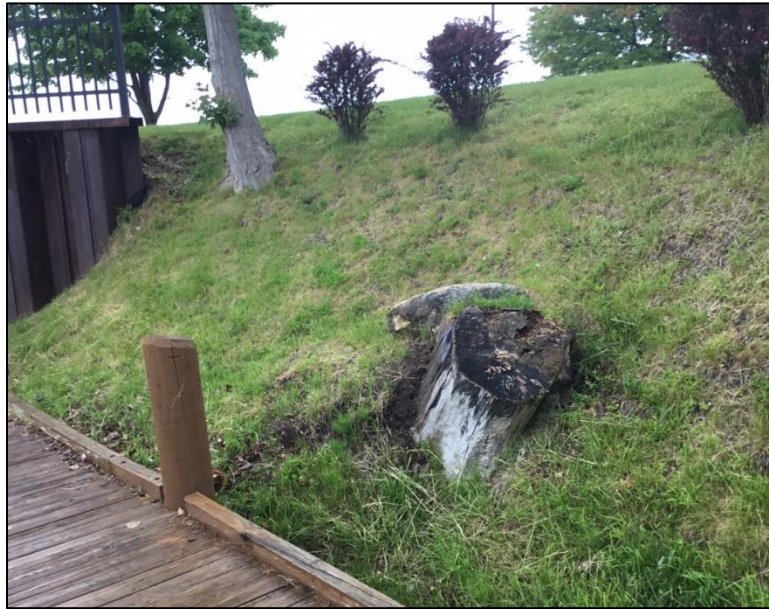
- Points 2a & 2b: Steep banks south of Harbor Drive, between Dexter and Cedar Streets – Only minor erosion was present, but turfgrass roots are not particularly good at stabilizing steep banks, so these slopes could fail in the near future. Mowing turfgrass in these steep areas is probably an unpleasant and potentially dangerous task anyway.
  - Replace turfgrasses with native plants such as *Rhus aromatica* (fragrant sumac), *Juniperus communis* (common juniper), and *Schizachyrium scoparium* (little bluestem). The native shrubs described under Point 1 can be used closer to the water.

*Points 2a and 2b have steep banks with high potential for future failures due to the poor stabilizing abilities of turfgrass*

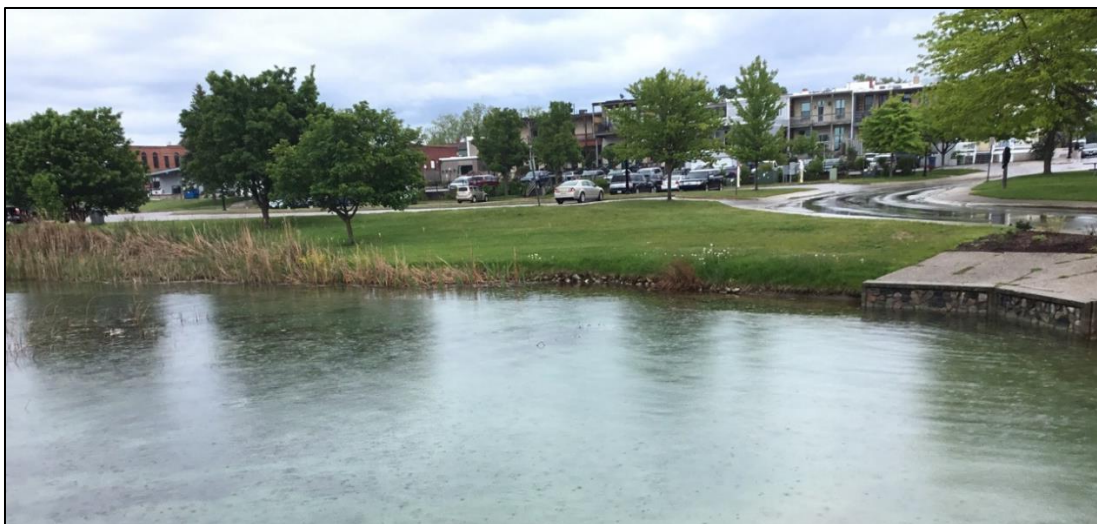
- Point 2c: Greenbelt dwindles away on west end as it approaches Cedar Street
  - Expand the west end of the greenbelt with a no-mow zone 20-50 feet wide.

*At Point 2c, the greenbelt dwindles away as it approaches Cedar Street (on the left). This image was taken from the north side, facing south.*

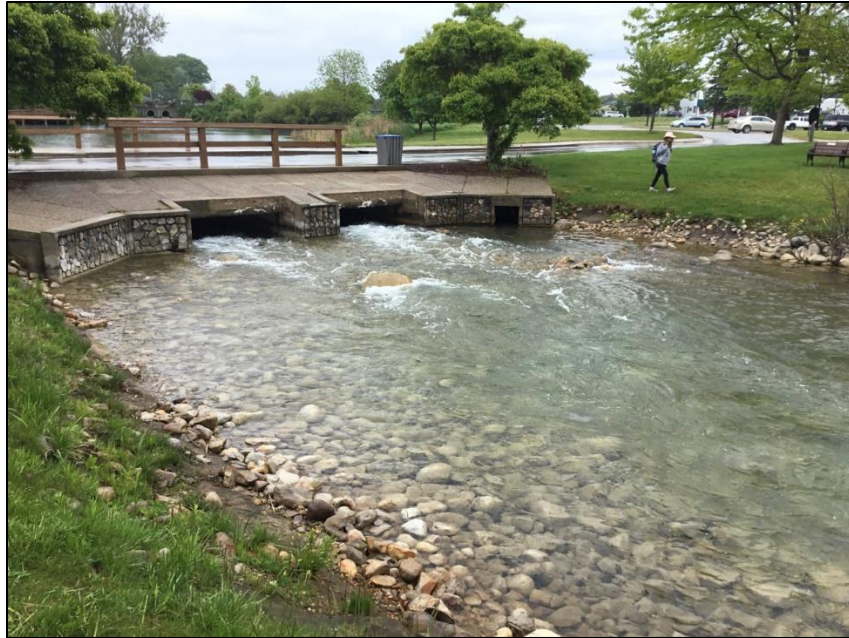
- Point 2d: Minor erosion along the bank which is currently stabilized with riprap and geotextile.
  - Adding native plants, such as those described under Point 1, would offer a more resilient and self-repairing approach to preventing erosion. Existing riprap and geotextile can be left in place to avoid disturbing the bank.

*Point 2d: Minor erosion and bare soil along the bank on the west side of the Cedar Street bridge*

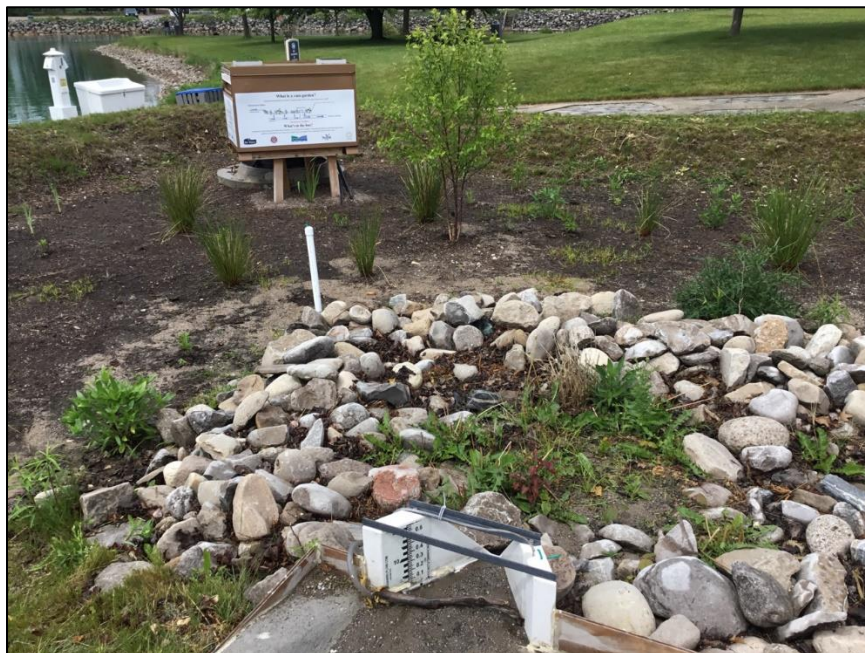
*Point 3: The rain garden southwest of the dam could be an eye-catching and functional example of nature-based stormwater management if it was better maintained.*

- Point 3: The rain garden in the corner of the parking lot to the southwest of the dam needs to be maintained to function as intended, and it also looks unattractive. In its current state, it is not going to encourage the public to desire more installations of pollutant-removing nature-based stormwater solutions.

- The accumulated sediment and organic material that has collected in the stone fore-basin of rain garden should be removed.
  - Additional native plants should be planted, in both the basis of the raingarden and on its sloping sides.

- Edging can be installed around the edges to create a line of separation between the rain garden and the adjacent turf. This will also keep turfgrasses from invading the rain garden.

1. Maintain and improve existing landscaping before beginning entirely new projects. Two sites in particular come to mind:
  - **The rain garden** southwest of the dam could be an eye-catching and functional example of nature-based stormwater management if it was better maintained. See recommendations under Point 3, above.

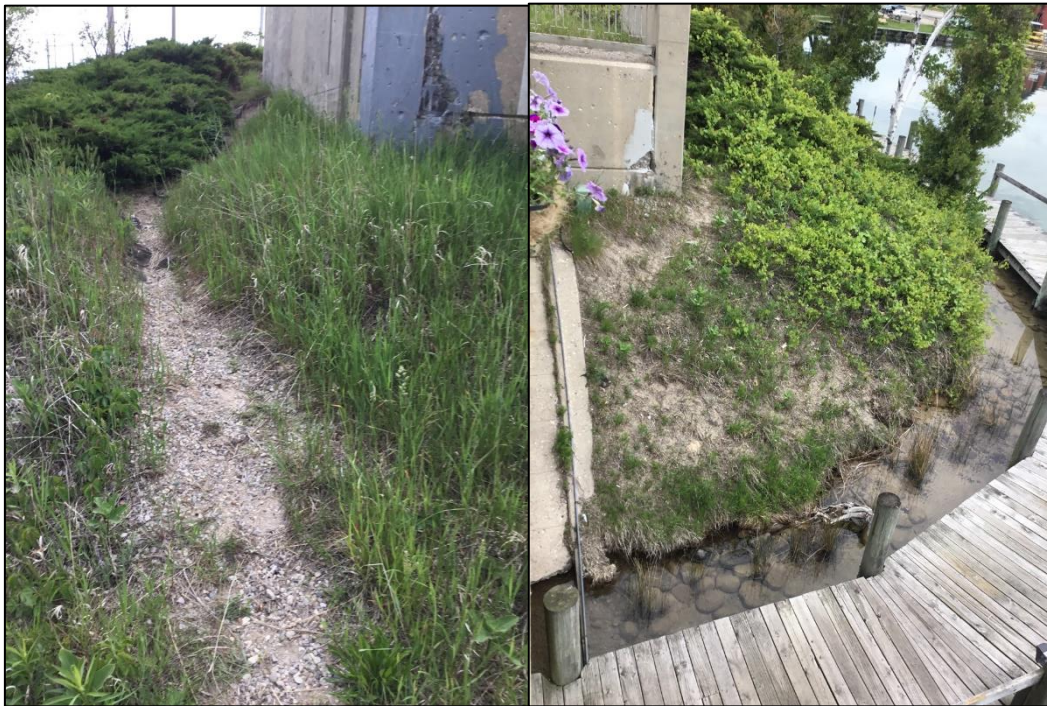
- Point 4a: Bare soil northeast footing of the US-31 bridge
  - Add native plants to cover bare soil, such as *Rhus aromatica* (fragrant sumac), *Juniperus communis* (common juniper), and *Schizachyrium scoparium* (little bluestem). The native shrubs described under 1a can be used closer to the water.

- Point 4b: Eroding foot path at northwest footing of US-31 bridge
  - Install steps or block access with fences or with plantings of *Rubus allegheniensis* (blackberry) or other species that will deter people from using this as a river access point.

Figure 7: Points 4b (left) and 4a (right), showing bare soil and eroding path.

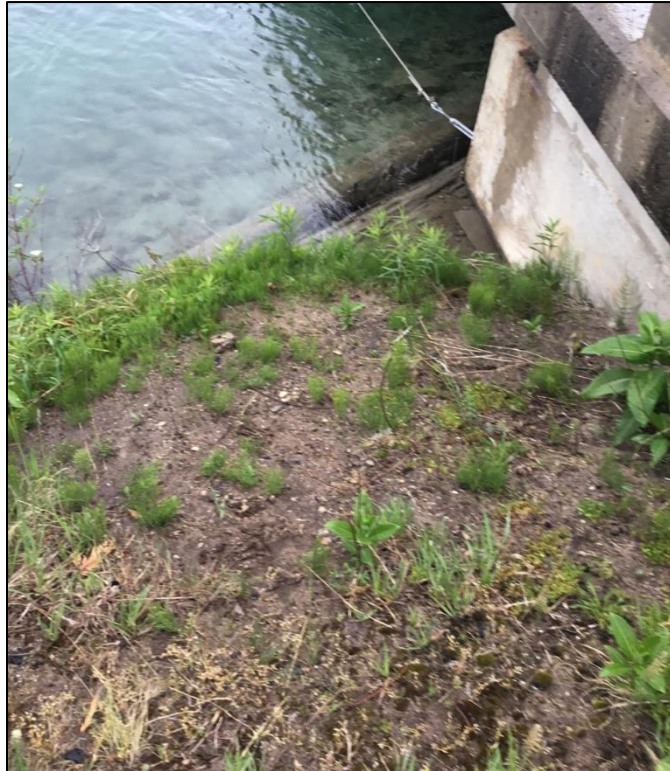
*Figure 8: Point 5 - Thinly vegetated soil at southeast corner of Dexter St bridge east of the dam*

- Point 5: Thinly vegetated soil at southeast corner of Dexter St bridge east of the dam
  - Install steps or block access as described under 4b, above.
  - Widen greenbelt from bridge to east with a no-mow zone or by planting native plants

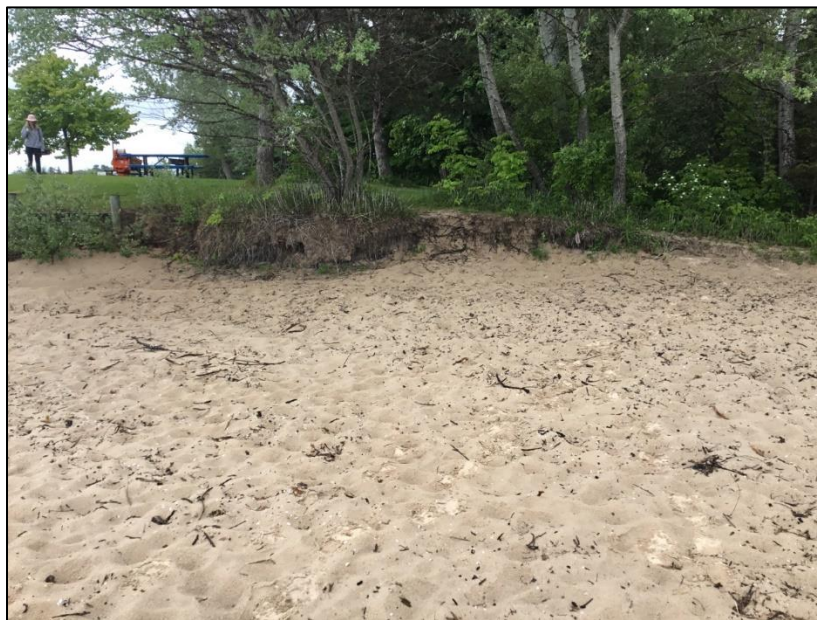
*Point 6: The edge of the beach along the woods is eroding due to foot traffic*

- Point 6: Eroding beach access area along edge of woods west of the library, near the south corner of the marina parking lot
  - Install steps to channel traffic to a designated access point or points, allowing the vegetation in other areas to recover

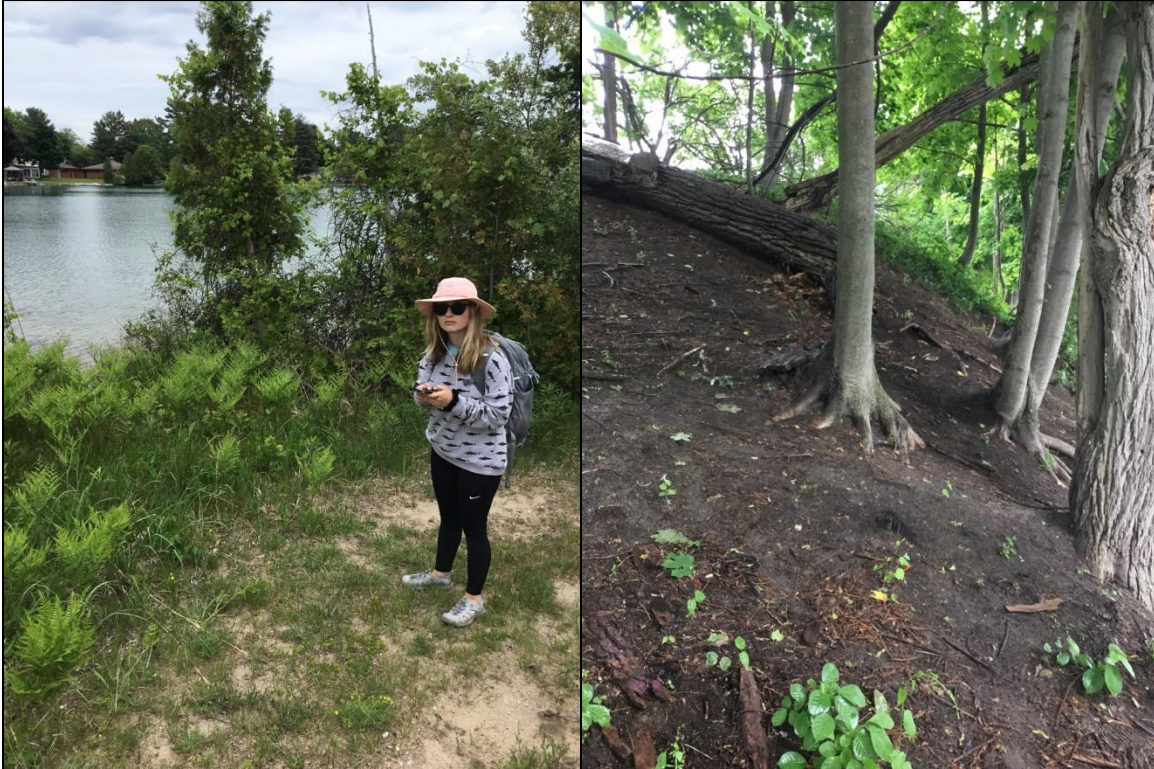
*Point 7 (left): Narrow greenbelts at Rotary Park could be widened to improve their ability to protect water quality and provide wildlife habitat. At right, Point 8: Bare soil on a steep slope in woods near the library should be monitored for signs of erosion.*

- Point 7: Most of the Rotary Park shoreline has a very narrow greenbelt, often only 5-10 feet.
  - Widen the greenbelt at Rotary Park by marking out a no-mow zone and/or by doing plantings of native plants. Monitor for and remove invasive plants that attempt to establish themselves in the expanded greenbelt.
- Point 8: Monitor bare soil on steep slope in woods south of library
  - Check back every five years and add native plants if needed to stabilize the slope.
